**DISTRICT PLAN – LISTED HERITAGE PLACE  
HERITAGE ASSESSMENT – STATEMENT OF SIGNIFICANCE  
HERITAGE ITEM NUMBER 609  
COMMERCIAL BUILDING AND SETTING, FORMER CHIEF POST  
OFFICE – 31 CATHEDRAL SQUARE, CHRISTCHURCH**

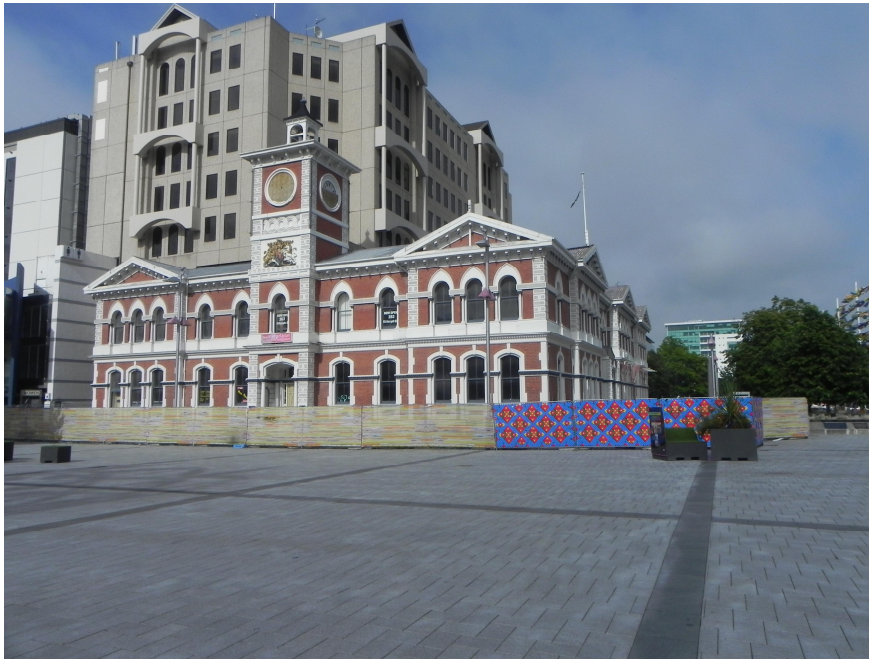
**PHOTOGRAPH : M.VAIR-PIOVA, 5/12/2014**

Burrows also designed the later addition to the west end of the north façade in 1907, which involved the extension of a third gabled bay to the western end of the north frontage. The former Chief Post Office is a two storey masonry building in the Italianate style, with richly textured ornamentation combining classical and Venetian Gothic elements. It combines classical arched windows on the ground floor with Venetian pointed arches on the first floor. A clock tower marks the entrance with the coat of arms above at roof level. Above this is the multi-faced clock which contained a bell which chimed and was in use until the middle of the 20th century when it was quietened due to noise complaints from the neighbouring United Service Hotel. The bell was re-commissioned around the 1990s and in use until the Canterbury earthquakes. The clock is currently boarded up and the hands have been removed and stored. In 1992 the interior was demolished due to the construction of the seven storey telecom building directly behind it. Although the interior alterations reduced the building's heritage values, its imposing L-shaped exterior continues to have a major aesthetic impact on Cathedral Square. The building was damaged in the Canterbury earthquakes but is stabilised and remains a key part of Cathedral Square.

The building is of technological and craftsmanship significance for what it may reveal of nineteenth century construction and craftsmanship methodologies and materials through its brick and stone construction and its examples of architectural detailing. These include decorative elements apparent in the string courses, eaves brackets, pediments and arches, as well as the prominent clock tower, with the British coat of arms and entrance on the eastern facade. The Chief Post Office's clock tower was installed in 1879 and contains a multi-faced single mechanism clock with a bell chime.
