CHRISTCHURCH DISTRICT PLAN – SCHEDULED HERITAGE PLACE

HERITAGE ASSESSMENT – STATEMENT OF SIGNIFICANCE

BOULDER BAY BACHES

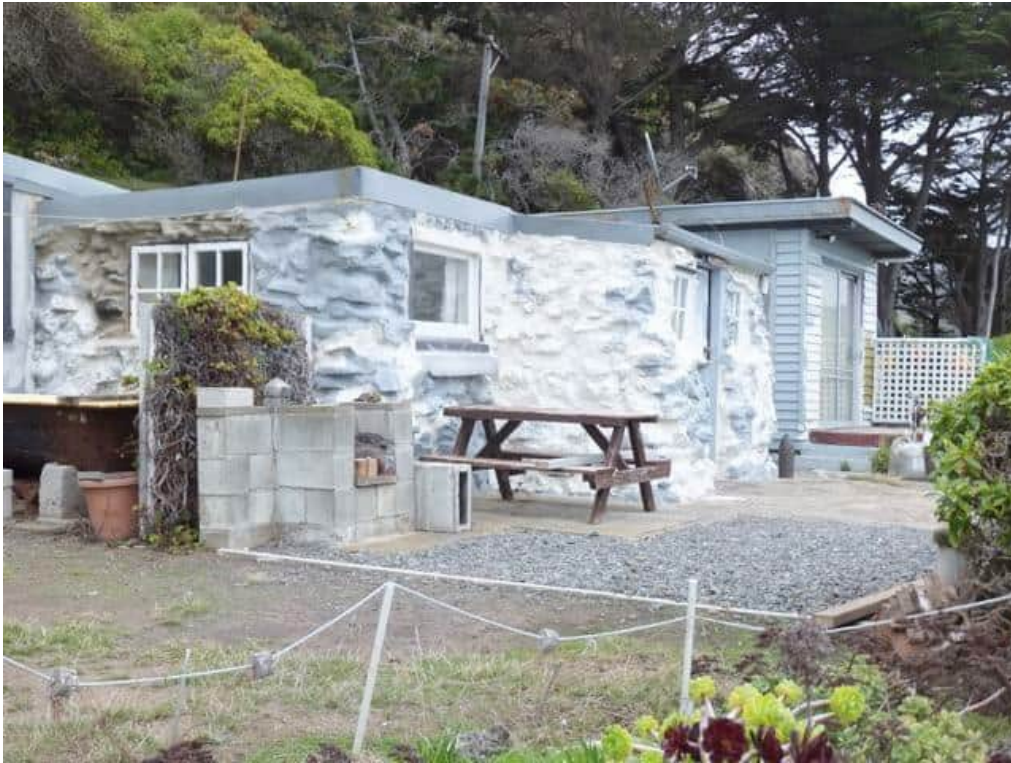
PHOTOGRAPH: D. McEWAN, 16 MAY 2013

The remote location of many Taylor's Mistake baches - where most materials had to be carried or boated in - encouraged the use of whatever was immediately to hand. Many of the first generation of baches in the locality were formed from shore-line caves. In the case of *Stone End*, Yardley built his home of boulders gathered from the adjacent beach and cemented them with loess clay from the hillside at the rear. A shallow mono-pitched corrugated iron roof channels water into tanks for domestic use. The unlined irregularly-planned interior consists of several small inter-linked spaces. Neighbouring *Rosy Morn* was built in a similar fashion. With their white-painted stone walls and small casement windows, the squat baches resemble crofters cottages, firmly anchored in their exposed seaside situation. The Roberts family has made some alterations to *Stone End* over the last seventy years, including a weatherboard bedroom at the western end. Whilst larger in scale, this room is still very much in the broader bach vernacular, and illustrates the accretive nature of these 'homes away from home'. *Stone End* remained in good repair and regular use until the Canterbury earthquake sequence of 2010-2011, when it sustained moderate damage.

Stone End has technological and craftsmanship significance for its construction of stone boulders cemented with clay. Whilst consistent with the vernacular traditions of bach building, the labour-intensive use of stone is highly unusual, and reflects the early provenance and isolated and exposed location of this dwelling. Neighbouring *Rosy Morn* is constructed in the same fashion.

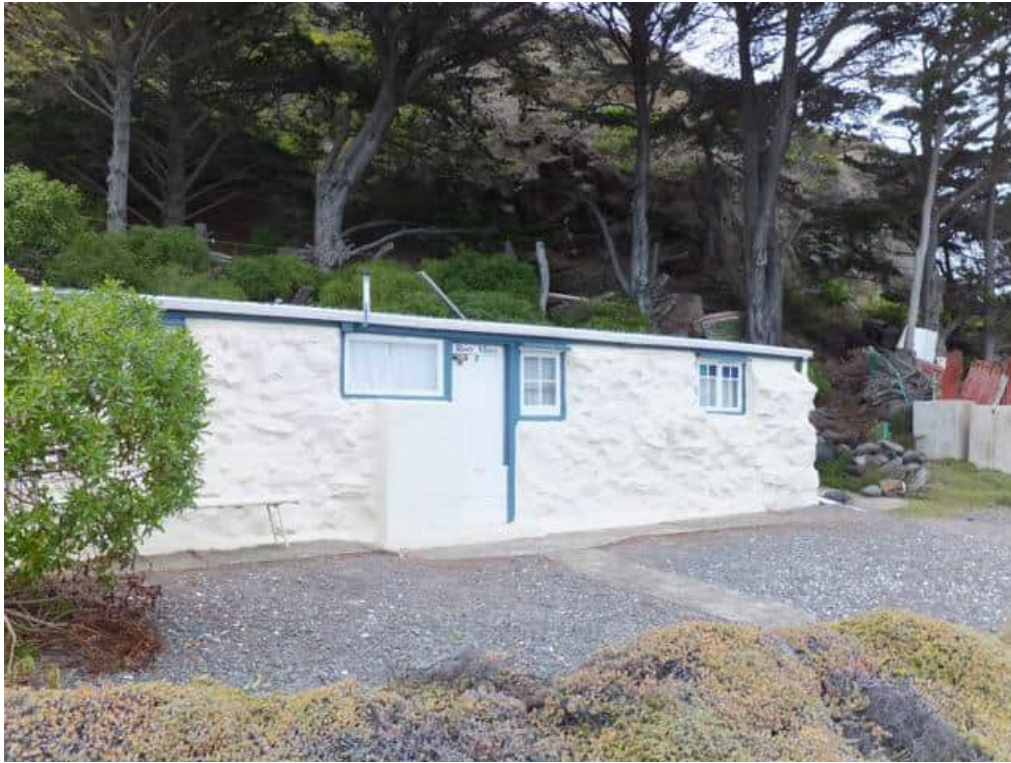
PHOTOGRAPH: D. McEWAN, 16 MAY 2013

The remote location of many Taylor's Mistake baches - where most materials had to be carried or boated in - encouraged the use of whatever was immediately to hand. Many of the first generation of baches in the locality were formed from shore-line caves. In the case of *Rosy Morn*, Caldwell and Beumelberg built their bach of boulders gathered from the adjacent beach and cemented them with loess clay from the hillside at the rear. A shallow mono-pitched corrugated iron roof channels water into tanks for domestic use. The unlined interior consists of several small inter-linked spaces. Neighbouring *Stone End* was built in a similar fashion. With their white-painted stone walls and small casement windows, the two squat baches resemble some misplaced Scottish crofters cottages, firmly anchored in their exposed seaside situation. As Harry Reading aged, *Rosy Morn* was neglected and the building required substantial repair when N Dunbar took over in the mid-1950s. The bach sustained moderate damage in Canterbury earthquake sequence of 2010-2011, but has been repaired and is in regular use. One of few alterations to its form and appearance has been the recent removal of much of the chimney and its replacement with an additional window.

Rosy Morn has technological and craftsmanship significance for its construction of stone boulders cemented with clay. Whilst consistent with the vernacular traditions of bach building, the labour-intensive use of stone is highly unusual, and reflects the early provenance and isolated and exposed location of this dwelling. Neighbouring *Stone End* is constructed in the same fashion.

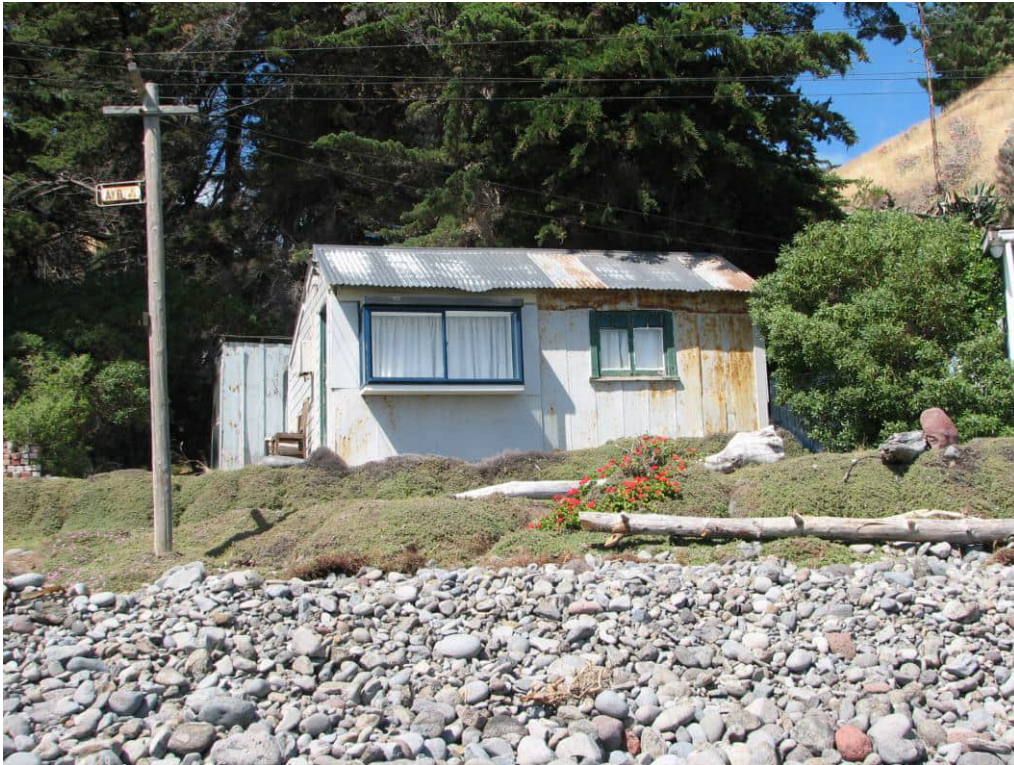
PHOTOGRAPH: G. WRIGHT, 9 FEBRUARY 2017

Bach 7 reflects the typology and characteristics of the 'kiwi' bach in its simple forms and materials. It is a simple gabled timber structure with a 'catslide' corrugated iron roof and rusticated weatherboard cladding on some sides. In the mid-20th century, an entry porch was filled in, larger casement windows were fitted and the seaward side was clad in flat iron sheet. More recently the large chimney on the north elevation was removed following damage sustained in the Canterbury Earthquake sequence of 2010-2011. An aluminium box window was fitted to the eastern elevation to replace an existing window about the same time. Many baches across Taylor's Mistake underwent modernisation in the post-war decades as expectations changed and new lower maintenance materials became available. Otherwise the bach has been little altered since construction and is also in reasonable repair. It therefore retains a moderate degree of integrity and authenticity.

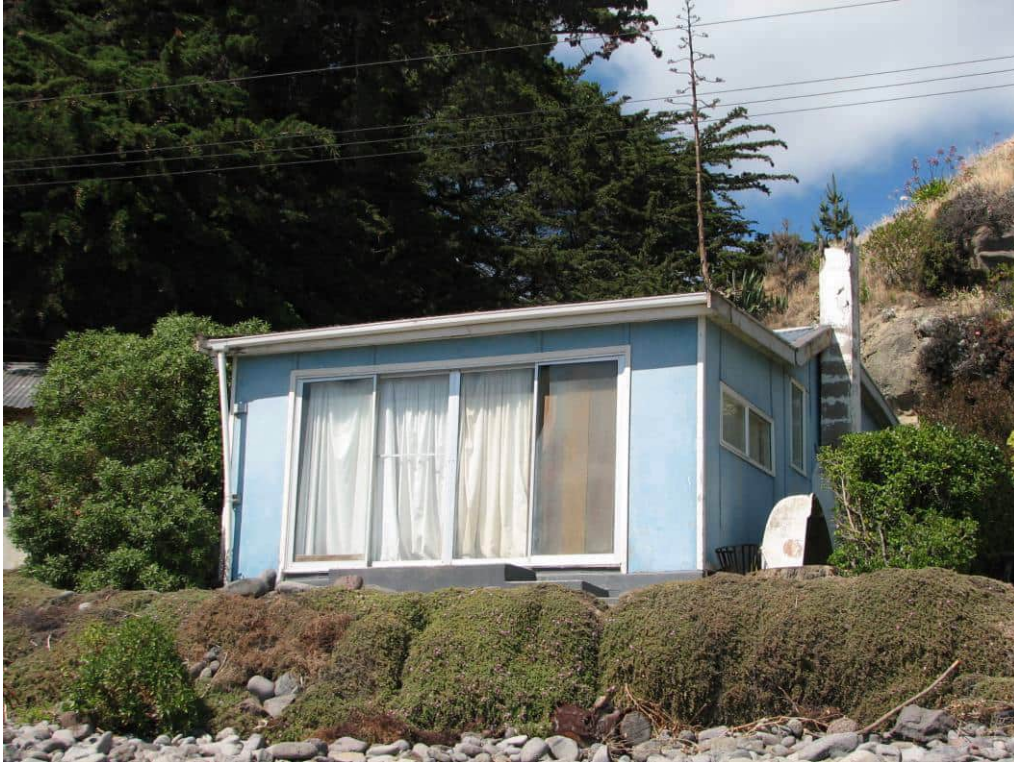
PHOTOGRAPH: G. WRIGHT, 9 FEBRUARY 2017

Bach 8 reflects the typology and characteristics of the 'kiwi' bach in its simple forms and materials. It appears to have begun life as a simple gabled structure with a cat-slide roof – not dissimilar to the adjacent Bach 7. Before World War II, a low-pitched addition was made to the front. During the 1960s and 1970s, Bill Thom modernized and upgraded the bach to accommodate his large family with assistance from neighbours Lance Robertson (Bach 6) and Dick Bain (Bach 4). The original board and batten cladding was removed and replaced with Polite, and the wooden windows replaced with aluminium. Many baches across Taylor's Mistake underwent modernisation in the post-war decades as expectations changed and new lower maintenance materials became available. The bach still retained its chimney in 2017. The bach is in reasonable condition given that it sustained some damage in the Canterbury Earthquake sequence of 2010-2011, which has not been repaired.

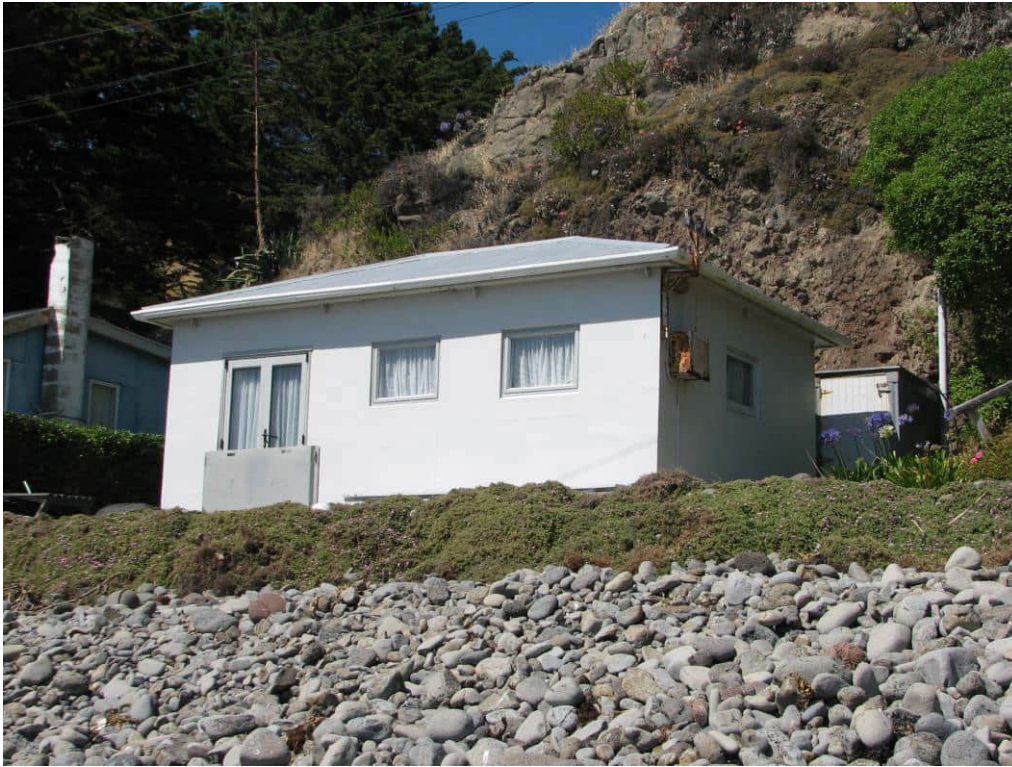
PHOTOGRAPH: G. WRIGHT, 9 FEBRUARY 2017

Bach 9 reflects the typology and characteristics of the 'kiwi' bach in its simple forms, lack of embellishment, and material used. It is a simple boxy form with a hipped corrugated iron roof. The poured concrete construction method was unusual at Taylor's Mistake at the time when most baches were timber. Baches 5, 31 and elements of 32 were built in a similar fashion. The form and diminutive scale of Bach 9 remain as built, but the fenestration has been altered. Originally the bach had a central door with windows either side; the door has since been closed off and the northern window replaced with French doors. The original timber windows have also been entirely replaced in aluminium. Despite this change, the bach still retains a moderate degree of authenticity.
