CHRISTCHURCH DISTRICT PLAN – SCHEDULED HERITAGE PLACE
HERITAGE ASSESSMENT – STATEMENT OF SIGNIFICANCE
TAYLOR’S MISTAKE BACHES - NORTH, CHRISTCHURCH

**CHRISTCHURCH DISTRICT PLAN – SCHEDULED HERITAGE PLACE
HERITAGE ASSESSMENT – STATEMENT OF SIGNIFICANCE
HERITAGE ITEM NUMBER 1446
*BACH AND SETTING - 48 TAYLOR’S MISTAKE BAY,
SCARBOROUGH***

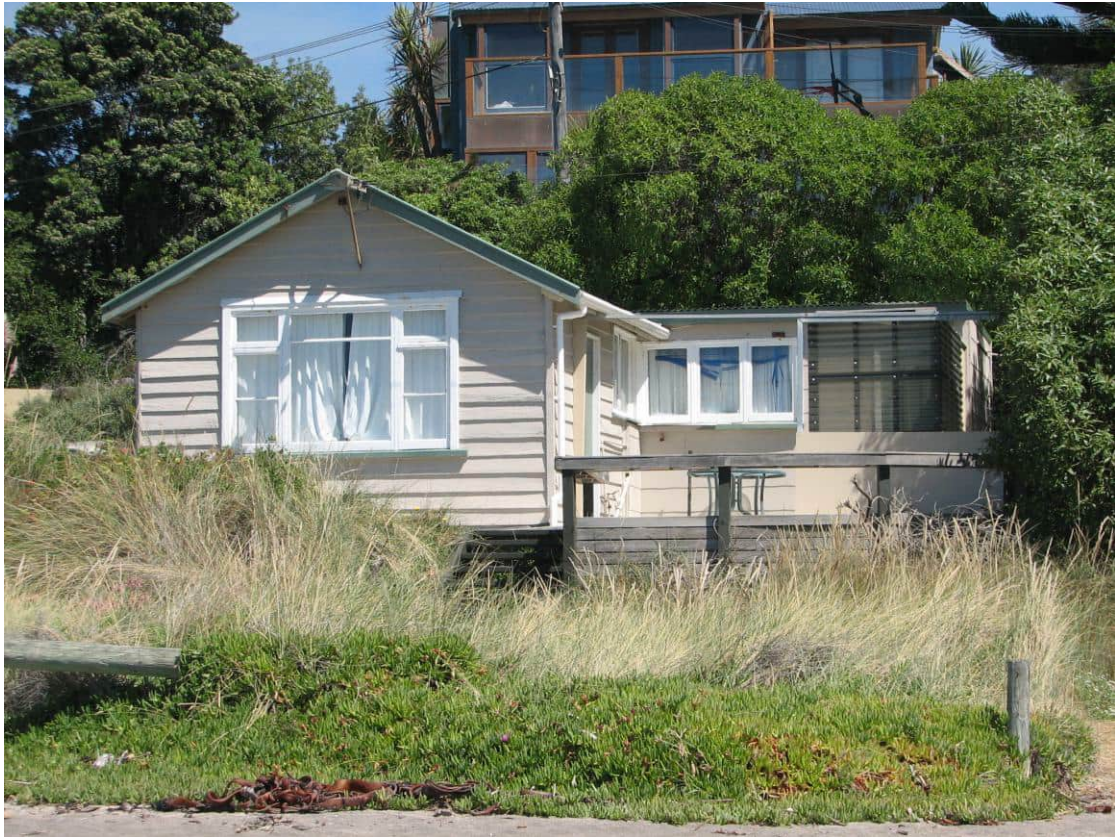
PHOTOGRAPH: G. WRIGHT, 2017

Bach 48 reflects the typology and characteristics of the 'kiwi' bach in its simple forms and materials. When constructed in the mid-1910s, it was a small gabled weatherboard hut of probably one room, sitting side-on to the sea, well out on the sands. In the mid-1920s it was either rebuilt or rotated on its site so that the gable faced the sea. The front door was relocated to the side elevation and a new window placed in the front elevation. The bach remained in this form until after its purchase by the Rowe family. A fibrolite lean-to extension (a bunkroom) was added to the rear in 1967, giving the building an 'L' shaped footprint. A larger window was also inserted in the front elevation. The bach sustained some damage in the Canterbury Earthquake sequence of 2010-2011, and the chimney was removed.

Bach 48 has technological and craftsmanship significance as a vernacular building, reflecting the building techniques and materials of the early and mid-20th century. The enlargement over time followed the trend of building more permanent baches. This bach began as a small weatherboard bach, with a bunkroom extension constructed of fibrolite in the late 1960s. The use of bought (rather than found) materials may have been a response to building regulations, as noted above, and the availability of materials such as fibrolite, which could be easily flat packed and carted, enabled construction at less cost than more traditional materials. Fibrolite fell out of favour in the 1970s and 80s³ and is not found in later alterations to baches meaning the alterations are specific to their time.

The bach is located on the sandy foreshore behind the Taylor's Mistake beach, in the area known as West End. The baches at the West end are tucked in to the cliff, with bush and scrub behind – either located directly on the beach, or up on the cliff. They are commonly timber weatherboard or fibrolite construction, with corrugated iron roofs and timber framed windows and doors. Most of the baches are single storied, with one a mix of single and two storied sections. Roof forms are gabled or mono pitched, or a mix of the two where there are later additions. Colours are predominantly light or dark tones. The baches located up on the cliff feature retaining walls and access stairs. Forms are generally rectangular and horizontal, extending across in line with the cliff.

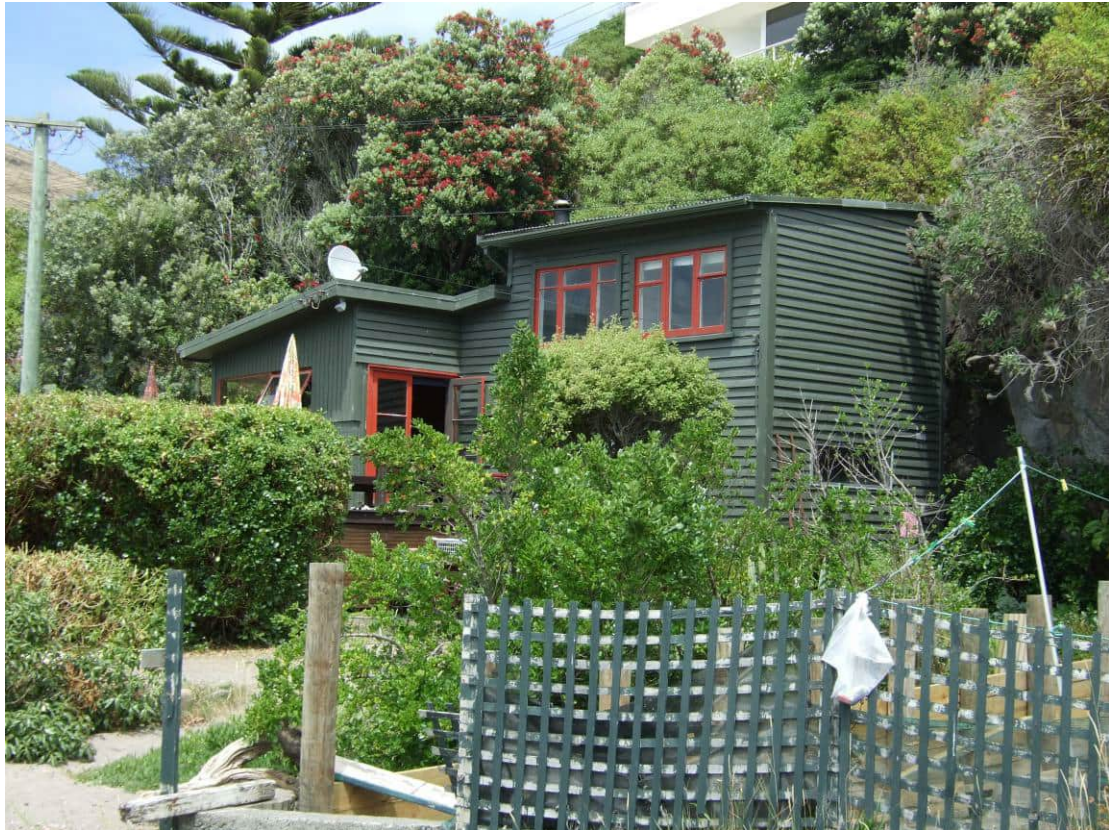
PHOTOGRAPH: G. WRIGHT, 14 JANUARY 2016

Early twentieth century baches were usually built without formal plans (or planning) of locally-sourced and found materials, and were often altered and adapted to suit the changing needs of owners. By mid-century, baches were usually more substantial structures, built of commercial materials. This was a reflection of the greater prosperity and higher expectations of the period. Although they were more akin to permanent dwellings, these baches resembled their predecessors in so far as they were usually designed by their owners and generally did not follow typical domestic models. Built for an informal lifestyle, they tended to adhere more to a mid-century deco or modernist-derived aesthetic, with features such as

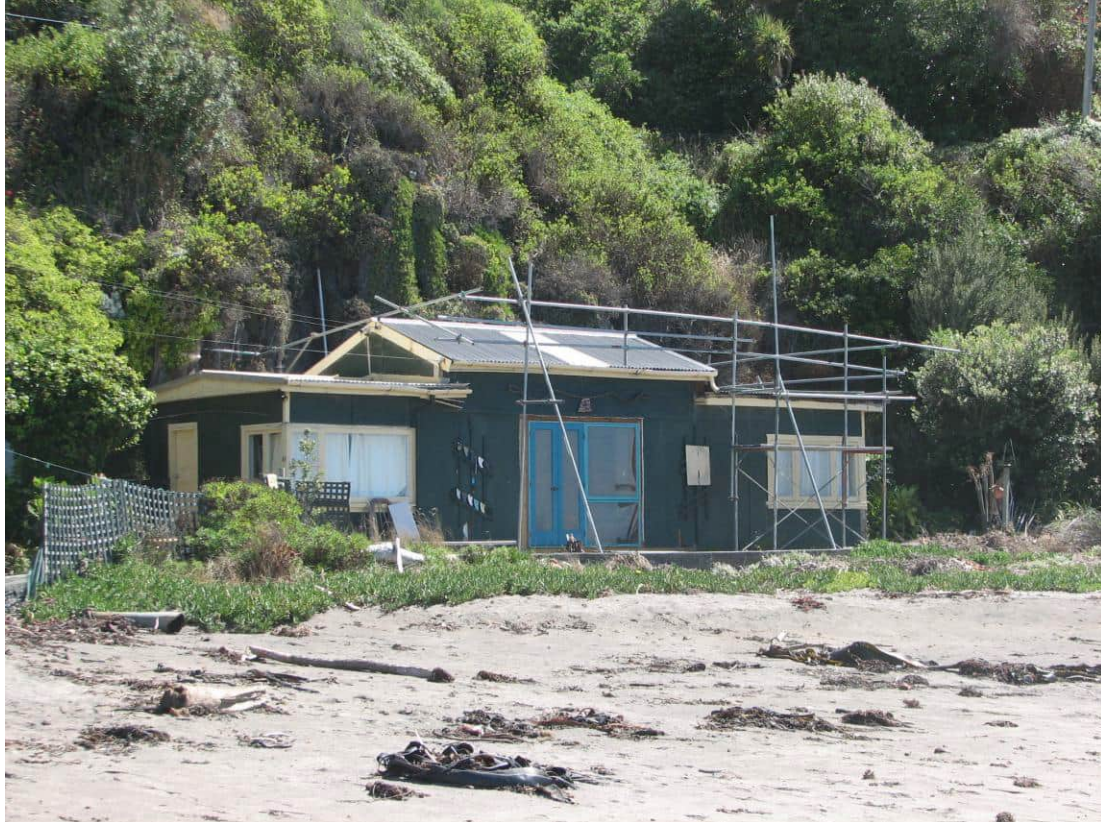
PHOTOGRAPH: G. WRIGHT, 2017

Bach 51 has technological and craftsmanship significance as a vernacular building, reflecting the building techniques and materials of the early and mid-20th century. The enlargement in the mid-20th century and the cladding of the bach in fibrolite followed the trend of building more permanent baches. The use of bought (rather than found) materials may have been a response to building regulations, as noted above, and the availability of materials such as fibrolite, which could be easily flat packed and carted, enabled construction at less cost than more traditional materials. Fibrolite fell out of favour in the 1970s and 80s⁴ and is not found in later alterations to baches meaning the bach is very much of its time.

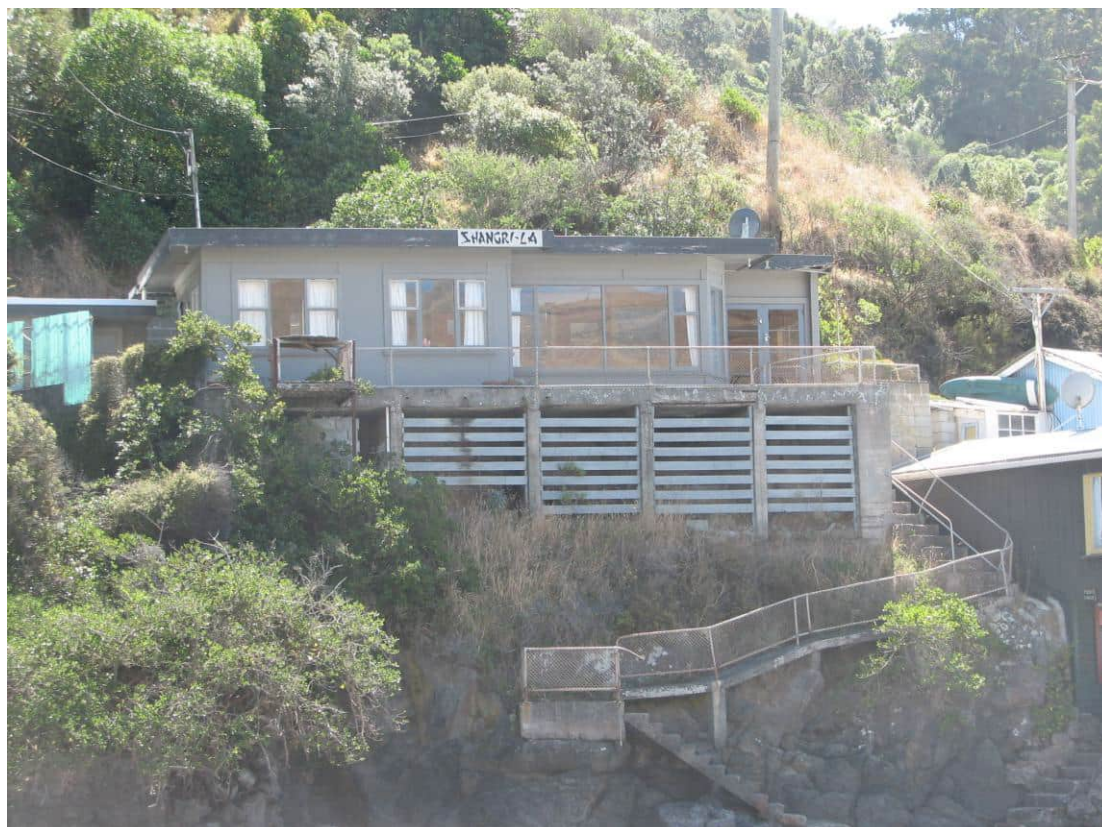
PHOTOGRAPH: G. WRIGHT, 2017

Bach 55 has technological and craftsmanship significance as a vernacular building, reflecting the building techniques and materials of the mid-20th century. The enlargement followed the trend of building more permanent baches. The use of bought (rather than found) materials may have been a response to building regulations, as noted above, and the availability of materials such as fibrolite, which could be easily flat packed and carted, enabled construction at less cost than more traditional materials. Fibrolite fell out of favour in the 1970s and 80s⁸.

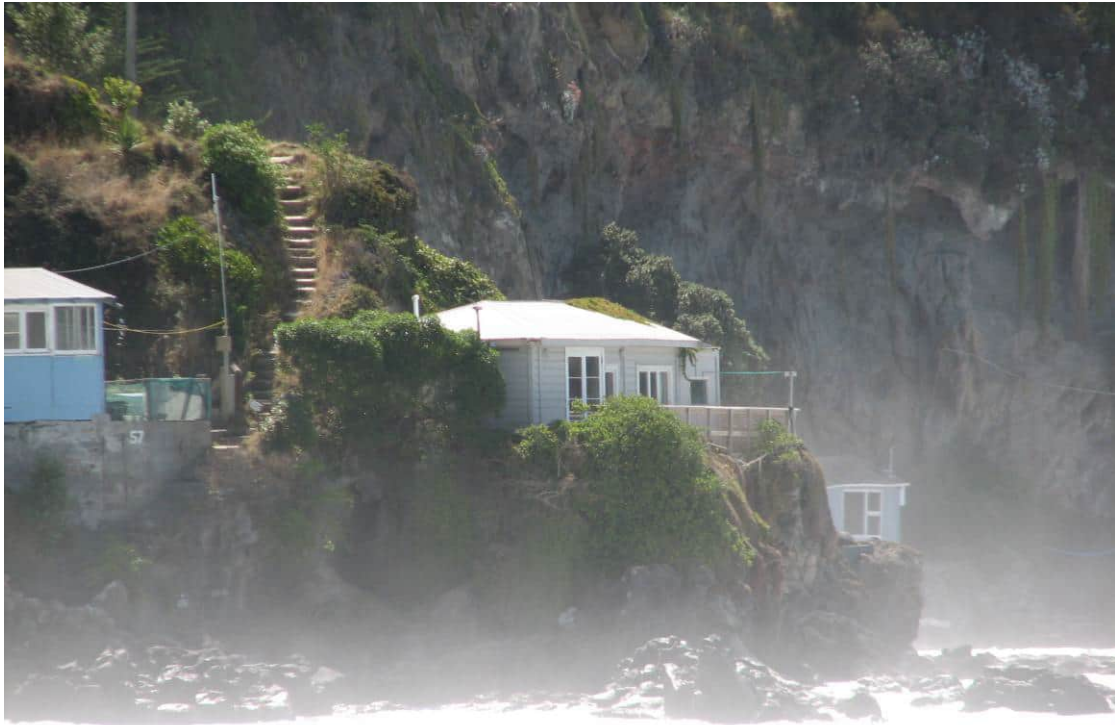
PHOTOGRAPH: G. WRIGHT, 2017

Bach 58 reflects the typology and characteristics of the 'kiwi' bach in its simple forms and materials. No clear images of the first Bach 58 have been sighted, but it appears to have been a small lean-to structure. By 1930 this had either been replaced or altered and had a gabled roof. The bach as it stands today is the larger rusticated weatherboard hip-roofed building that Alec Thompson built or rebuilt in 1936. Subsequent alterations include new windows inserted in the 1960s or 1970s. In terms of the evolution of bach design at Taylor's Mistake, it marks the transition between the simple lean-to's of the 1910s and 1920s and the more substantial fibrolite dwellings of the post-war period.

Bach 58 has technological and craftsmanship significance as a vernacular building, reflecting traditional building techniques and materials of the mid-20th century. The changes over time followed the trend of building more permanent baches. The use of bought (rather than found) materials may have been a response to building regulations, as noted above.

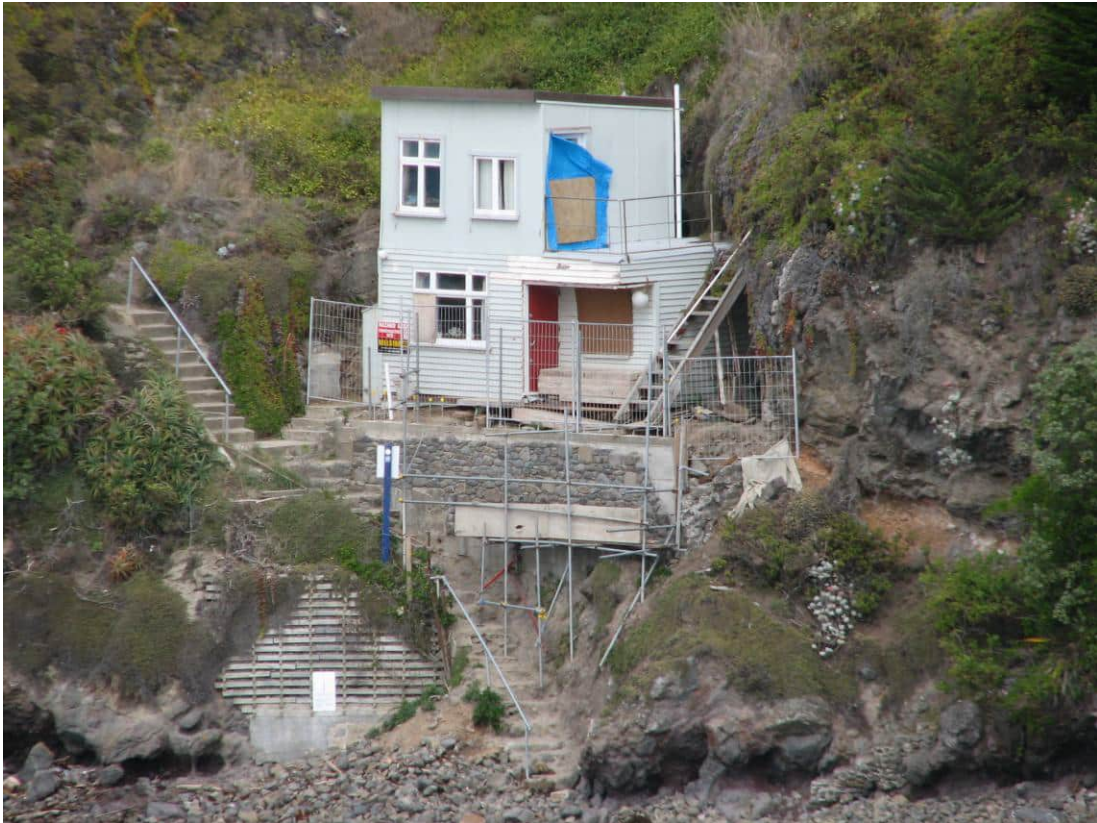
PHOTOGRAPH: G. WRIGHT, 2017

Bach 60 has technological and craftsmanship significance as a vernacular building, reflecting the building techniques and materials of the mid-20th century. The enlargement followed the trend of building more permanent baches and was constructed from fiber-cement rather than the original weatherboard. The use of bought (rather than found) materials may have been a response to building regulations, as noted above, and the availability of materials such as fibrolite, which could be easily flat packed and carted, enabled construction at less cost than more traditional materials, which is demonstrated in the upper storey of this bach. Fibrolite fell out of favour in the 1970s and 80s¹⁶ and is not found in later alterations to baches.

The building is constructed on an area supported by retaining walls necessitating some engineering ingenuity by the original builder which has been updated over time. Although this has required rebuilding after the Canterbury earthquakes it has been able to be repaired and the building has been retained.

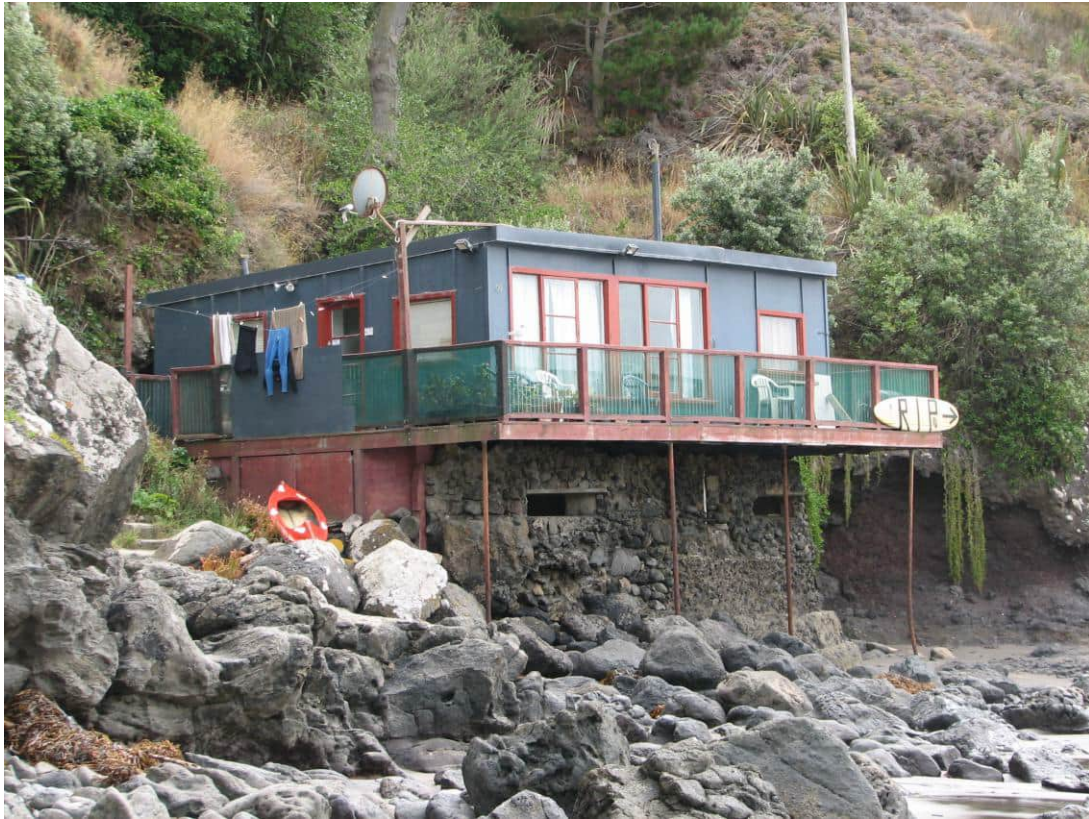
PHOTOGRAPH: G. WRIGHT, 2017

Bach 69 has technological and craftsmanship significance as a vernacular building, reflecting the building techniques and materials of the mid-20th century, and also illustrating military concrete pillbox construction. The construction of the bach in 1957 followed the trend of building more permanent baches. The use of bought (rather than found) materials may have been a response to building regulations, as noted above, and the availability of materials such as fibrolite, which could be easily flat packed and carted, enabled construction at less cost than more traditional materials. Fibrolite fell out of favour in the 1970s and 80s¹⁷ and is not found in later alterations to baches. The building is constructed on the previously built pillbox, and then jettied over the rocks supported on metal poles, demonstrating clever use of the existing structure and some ingenuity on the part of the builders.

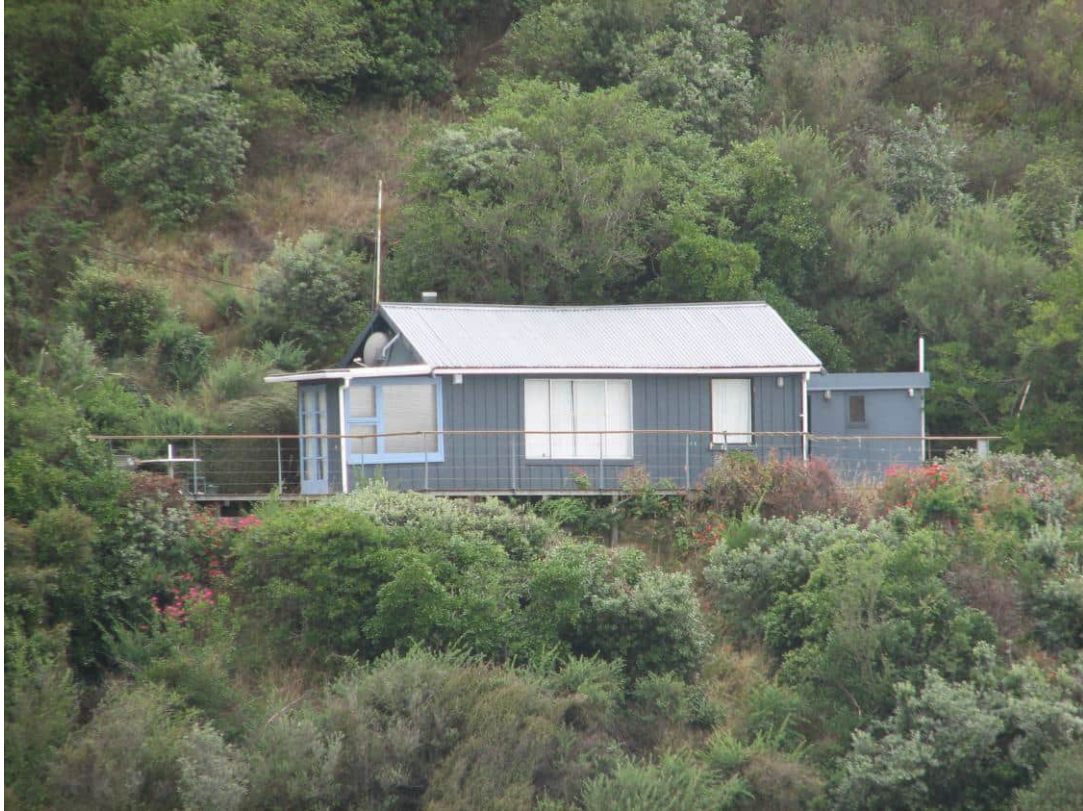
PHOTOGRAPH: G. WRIGHT, 2017

Bach 70 reflects the typology and characteristics of the 'kiwi' bach in its simple forms and materials. It began as a small gabled board and batten hut of one or two rooms. Modest additions have been made over the years. In the 1970s a small flat roofed extension was made to the south elevation, and later, a similarly-scaled bathroom extension to the north. The roof is corrugated iron and windows are a mix of timber framed and metal/aluminium. French doors open on to a deck which runs around the front and side of the bach, with wire balustrading. The bach remains in good condition and in use following the Canterbury earthquakes.
