**CHRISTCHURCH DISTRICT PLAN – SCHEDULED HERITAGE PLACE**  
**HERITAGE ASSESSMENT – STATEMENT OF SIGNIFICANCE**  
***TAYLOR’S MISTAKE BACHES - SOUTH, CHRISTCHURCH***

**CHRISTCHURCH DISTRICT PLAN – SCHEDULED HERITAGE PLACE  
HERITAGE ASSESSMENT – STATEMENT OF SIGNIFICANCE  
HERITAGE ITEM NUMBER 1390  
*BACH AND SETTING, 28 TAYLOR’S MISTAKE BAY,  
SCARBOROUGH***

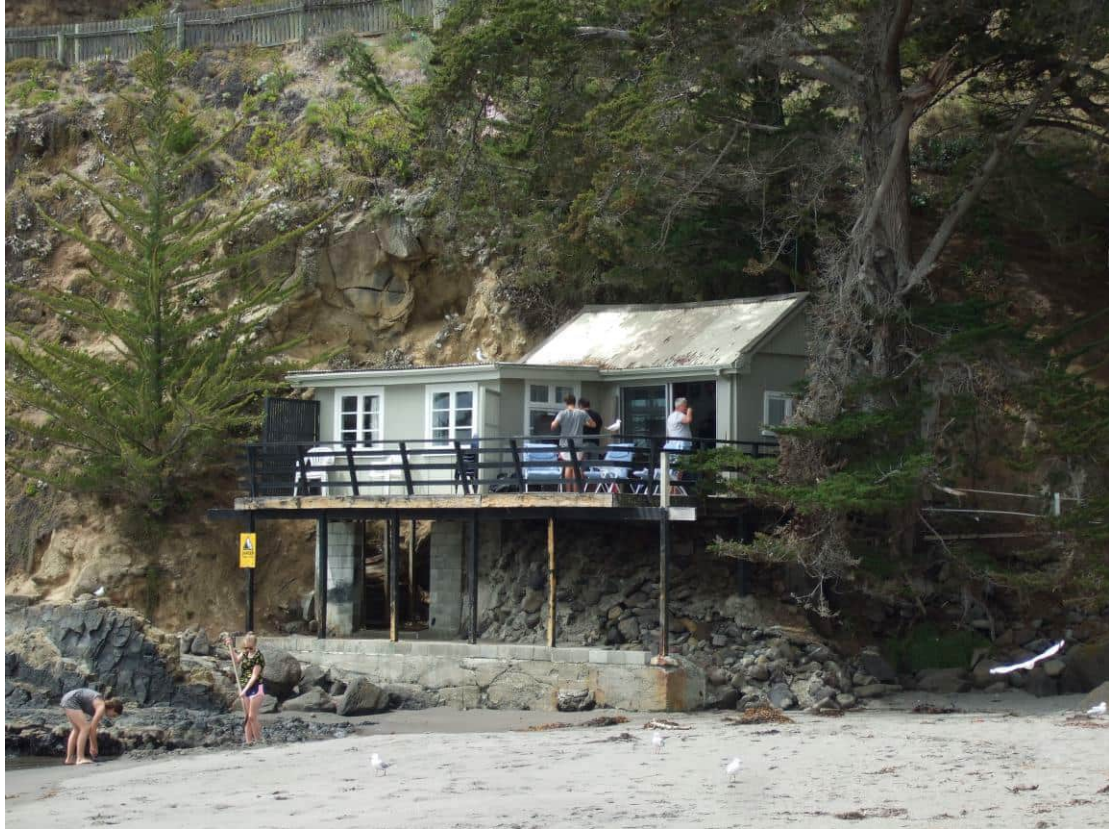
**PHOTOGRAPH: G. WRIGHT, 8 JANUARY 2016**

Bach 30 has architectural and aesthetic significance as an example of the small vernacular dwellings that were typically built to serve as baches in the early decades of the twentieth century. Such dwellings were usually built without formal plans (or planning) of locally-sourced and found materials, and were often altered and adapted to suit the needs of owners as required.

The bach sustained minor damage in the Canterbury earthquake sequence of 2010-2011, but was subsequently identified as being at risk of rock fall. Whilst the owners were unavoidably absent, the building suffered badly at the hands of vandals. As a consequence, bathroom and kitchen facilities required replacement. Beyond the post-earthquake repairs, and the insertion of a ranch-slider in the north elevation, the bach has been little altered since the 1930s. Consequently it retains a high degree of authenticity and integrity.

Bach 30 has contextual significance on its site and within its setting. The bach is perched on the rocky foreshore above the Taylor's Mistake beach, its foundations regularly washed by the sea. It is situated at the northern end of the group of baches known as Rotten Row. The contextual significance of the bach is derived partly from its location in what is an elemental coastal landscape, and partly from its association with the other small scale and informally-

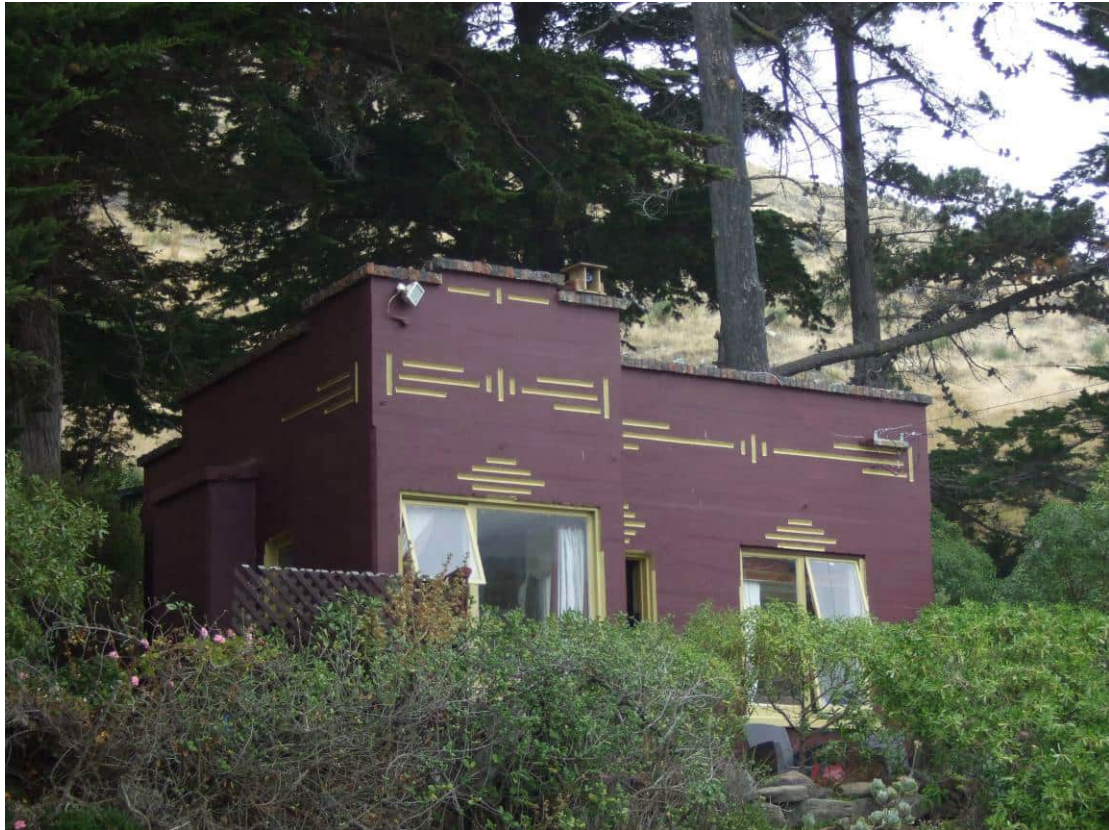
**PHOTOGRAPH: G. WRIGHT, 8 JANUARY 2016**

In the 1960s, Haxell set slightly larger windows into the front elevation of 31 to let more light into the interior. A chimney and fireplace also appear to have been removed at a comparatively early date, and replaced with a built-in cupboard unit (still extant). In the decade after purchasing the bach in the early 1980s, Ray Rankin substantially altered the interior, removing the central wall and ceiling, and relining throughout. The exterior has not been altered however, and retains its 1940s Art Deco appearance. Consequently the building retains its authenticity and integrity. The substantially-constructed bach sustained little damage in the Canterbury earthquake sequence of 2010-2011.

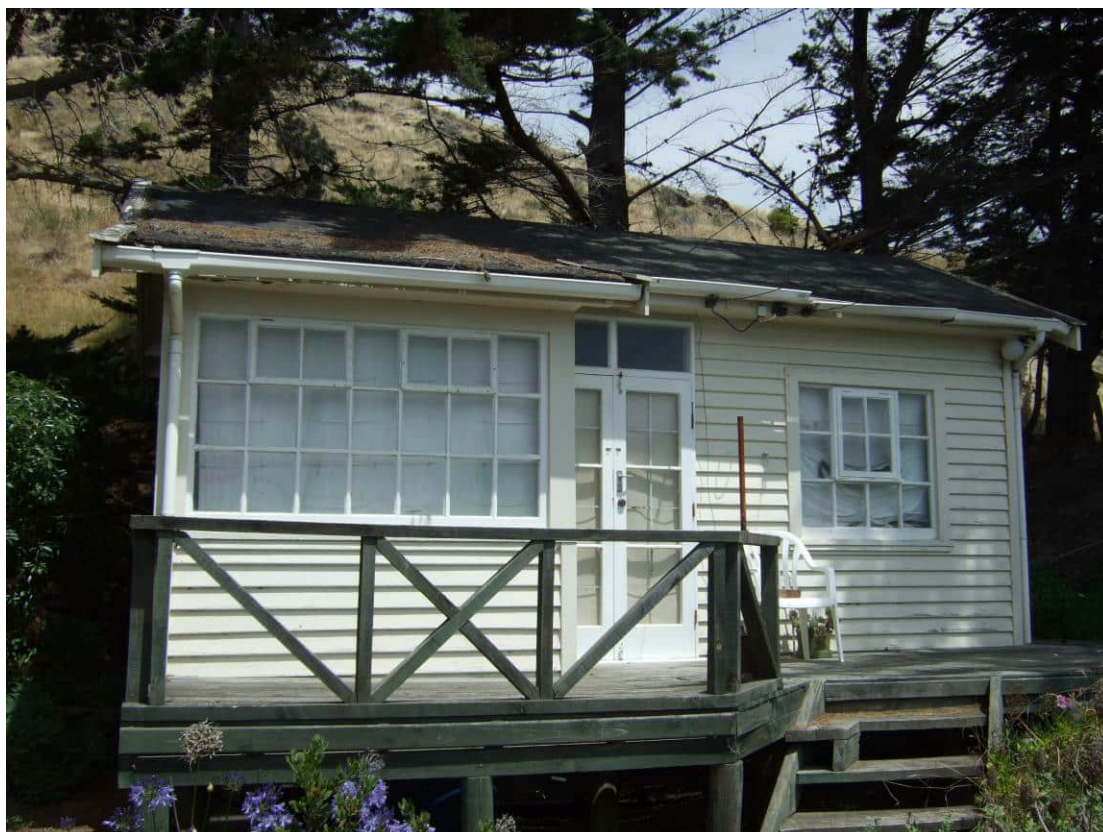
**PHOTOGRAPH: G. WRIGHT, 14 JANUARY 2016**

Apart from the addition of a deck, Bach 32 and its adjacent bunkhouse have been little altered since they were first constructed seventy years ago, and therefore retain their authenticity and integrity. They appear to have sustained little damage in the Canterbury earthquake sequence of 2010-2011.

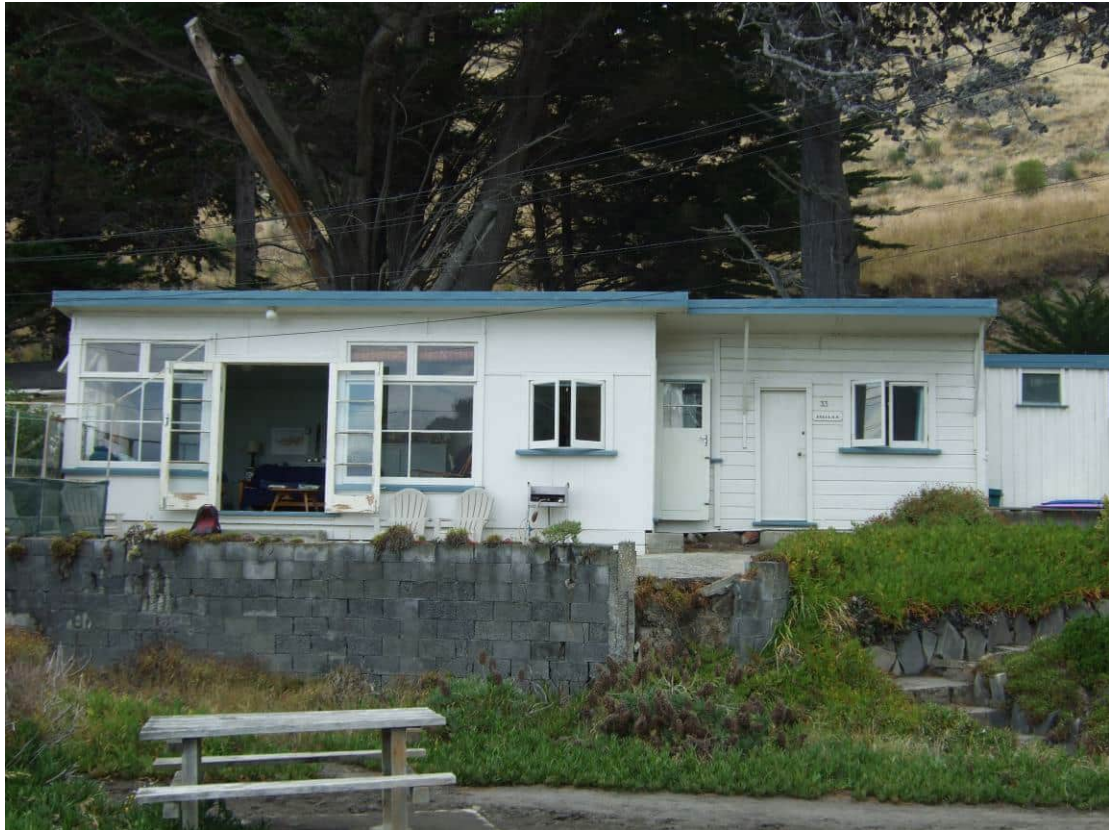
**PHOTOGRAPH: G. WRIGHT, 8 JANUARY 2016**

The first Bach 33 – probably built by C. Smith in the 1920s – was apparently a single room rusticated weatherboard hut with a skillion roof. At an early date the building was extended to the east with a second room. A board and batten bathroom was added to the western end in the 1930s. In 1953 new owners Barbara Anderson and Margaret Campbell added a substantial fibrolite lounge extension and rebuilt the kitchen at a total cost of £400, transforming the hut into a comfortable sunny modern weekend retreat suitable for entertaining. The bach has been little altered in the intervening years and still retains its authentic 1953 appearance, with original joinery, light fittings and a tiled deco fireplace. The substantially-constructed bach sustained moderate damage in the Canterbury earthquake sequence of 2010-2011, and the concrete chimney was lost.

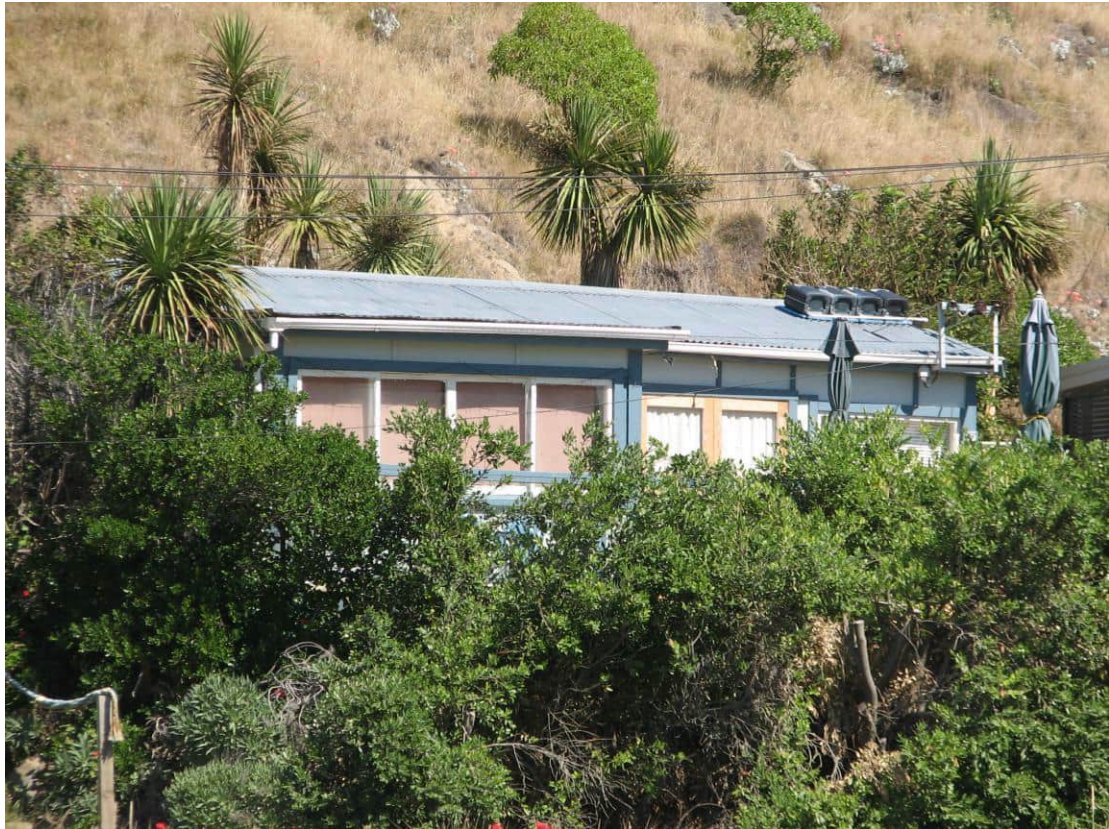
**PHOTOGRAPH: G. WRIGHT, 2017**

Bach 35 reflects the typology and characteristics of the 'kiwi' bach in its simple forms and materials. It began life before 1920 as a modest skillion-roofed weatherboard hut. The beach elevation featured a central door framed by two small windows. In early photographs of the 1920s and '30s, it was painted a dark colour with light trim. In the late 1930s, this bach was extensively altered or replaced with the present building, a larger gabled structure clad in ferro-cement sheet, reflecting the changes in approaches to bach building at the time. The beach elevation was later altered (as were many in the post war decades) with a lean-to bay and French doors.

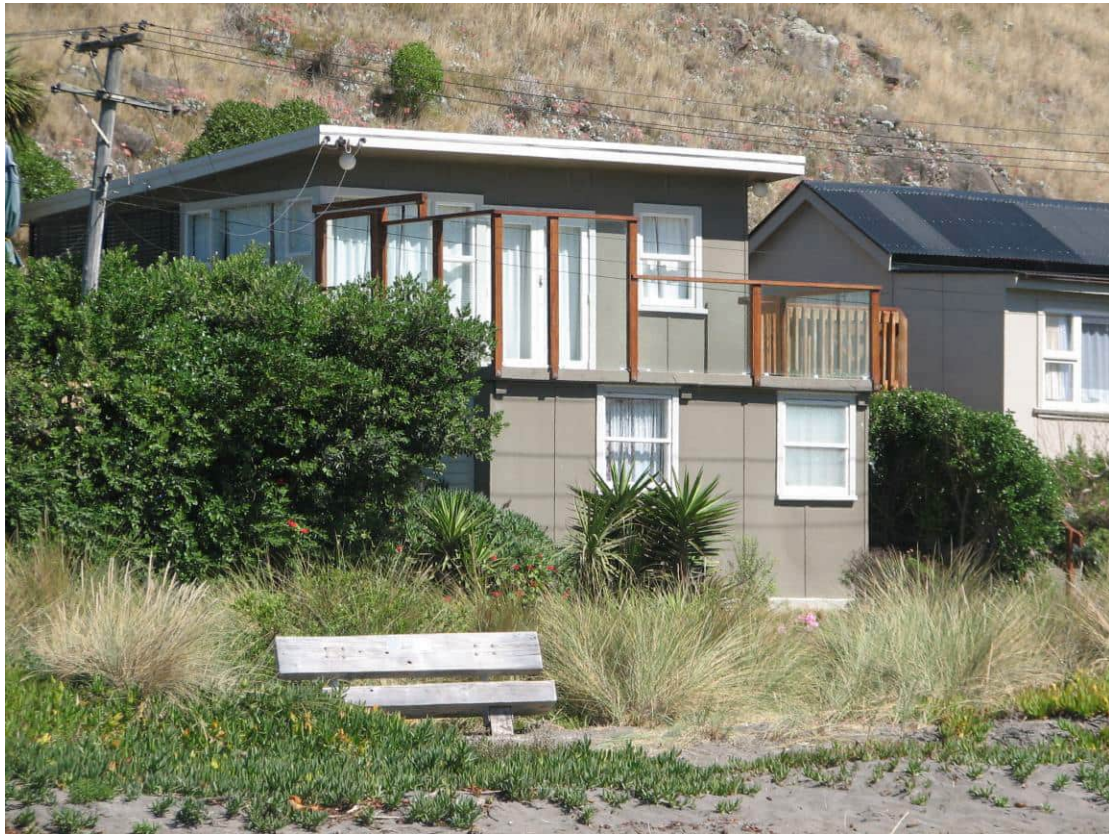
**PHOTOGRAPH: G. WRIGHT, 2017**

Bach 36 reflects the typology and characteristics of the 'kiwi' bach in its simple forms and materials. It is a typical mid-century fibrolite bach. The bach is two storied, with a deck extending over part of the ground floor, accessed from the second storey via glazed doors. The roof is mono pitched, only very slightly angled. The form is boxy and simple. Windows are timber framed, and a mix of smaller openings with two sets of larger groups of windows meeting on one corner. This results in a high percentage of glazing on the upper floor of the front façade. Stained timber balustrading of the deck appears to be a later addition.

Bach 36 has technological significance as a vernacular building designed and constructed by owners the Eastwick family to meet their requirements, and for its reflection of the building techniques and materials that were being used for baches in the mid-20<sup>th</sup> century. The rebuild in 1967 followed the trend of building more substantial baches. The use of bought (rather than found) materials may have been a response to building regulations, as noted above, and the availability of materials such as fibrolite enabled larger constructions at less cost than more traditional materials. Fibrolite fell out of favour in the 1970s and 80s<sup>9</sup>, and is not found in later alterations to baches.

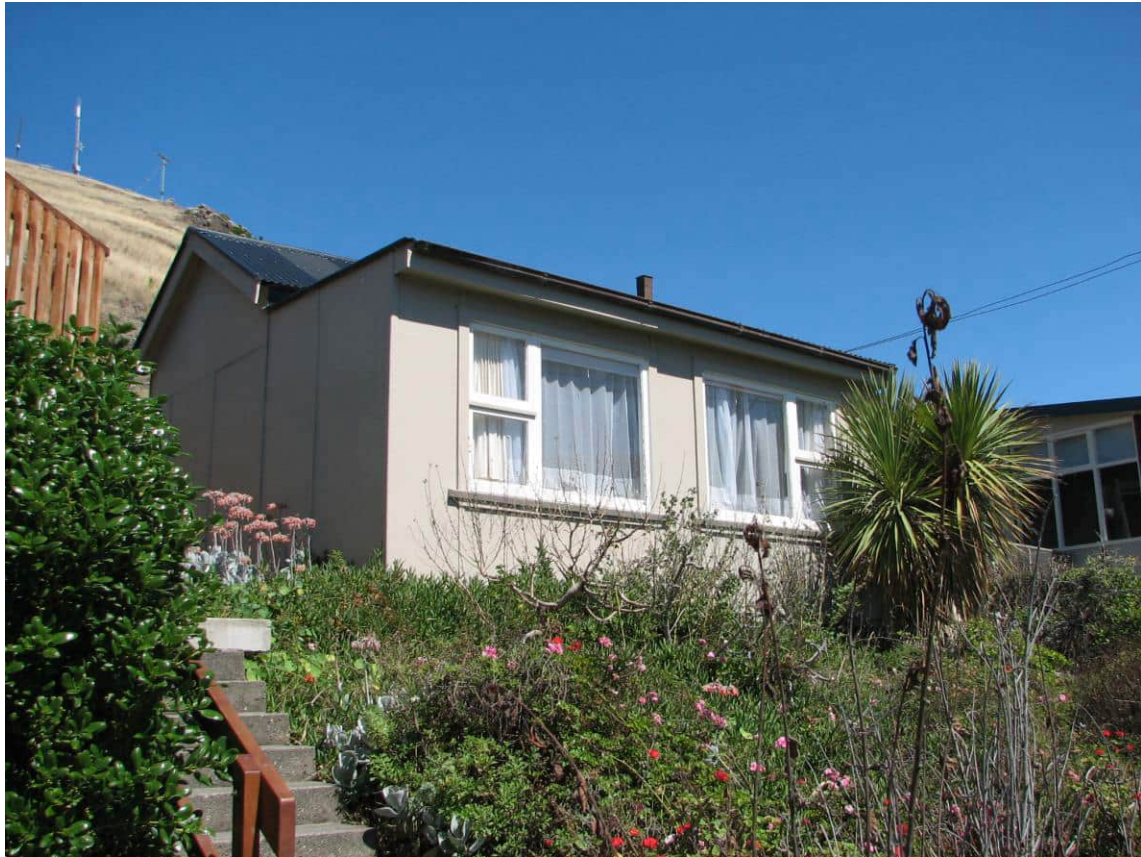
**PHOTOGRAPH: G. WRIGHT, 2017**

Bach 37 has technological and craftsmanship significance as a vernacular building, reflecting the building techniques and materials of the early and mid-20<sup>th</sup> century. Bach 37 has technological significance as a vernacular building designed, constructed and altered over time by the Shanks family to meet their requirements, and for its reflection of the building techniques and materials that were being used for baches in the mid-20<sup>th</sup> century. The changes over time followed the trend of building more substantial baches. The use of bought (rather than found) materials may have been a response to building regulations, as noted above, and the availability of materials such as fibrolite enabled construction at less cost than more traditional materials. Fibrolite fell out of favour in the 1970s and 80s<sup>11</sup> and is not found in later alterations to the baches, so the bach is very much a product of its time.

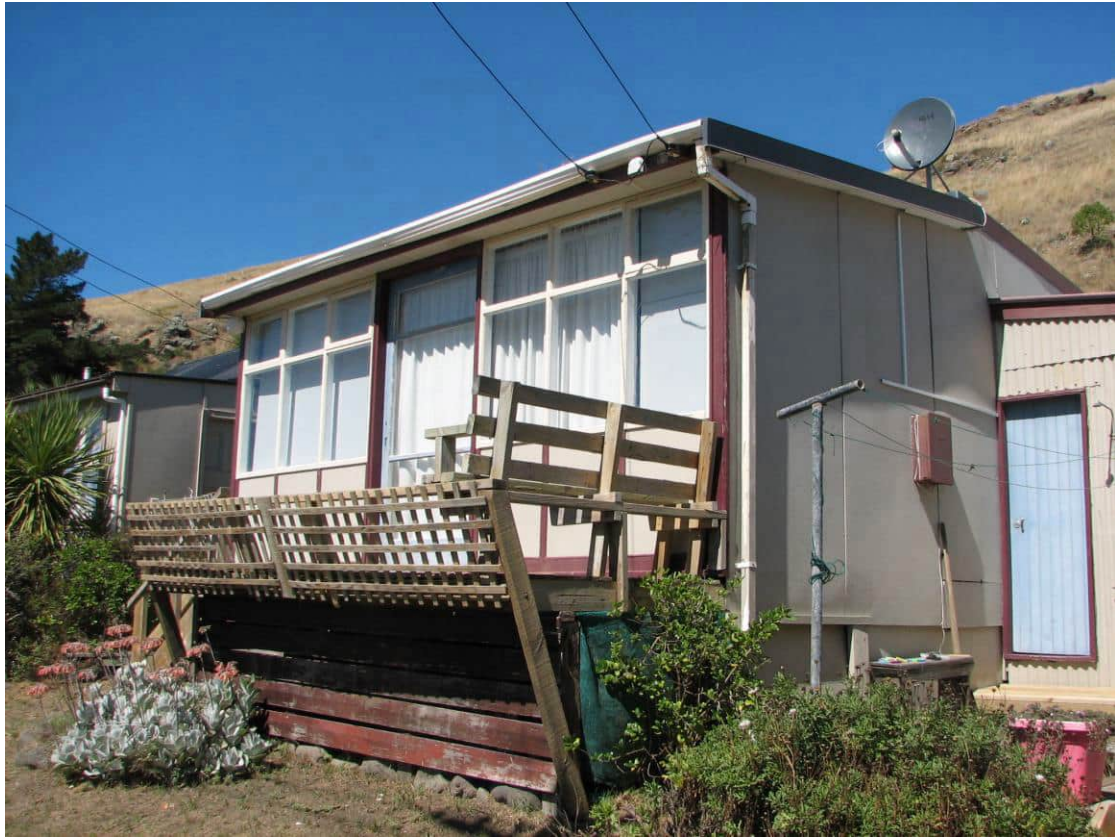
**PHOTOGRAPH: G. WRIGHT, 2017**

Bach 38 has technological and craftsmanship significance as a vernacular building, reflecting the building techniques and materials of the early and mid-20<sup>th</sup> century. Bach 38 has technological significance as a vernacular building constructed and altered over time by its occupants to meet their requirements, and for its reflection of the building techniques and materials that were being used for baches in the mid-20<sup>th</sup> century. The changes over time followed the trend of building more substantial baches. The use of bought (rather than found) materials may have been a response to building regulations, as noted above, and the availability of materials such as fibrolite, which could be easily flat packed and carted, enabled construction at less cost than more traditional materials. Fibrolite fell out of favour in the 1970s and 80s<sup>14</sup>, and is not found in later alterations to the baches, so the bach is very much a product of its time. Part of the building is clad in corrugated iron.

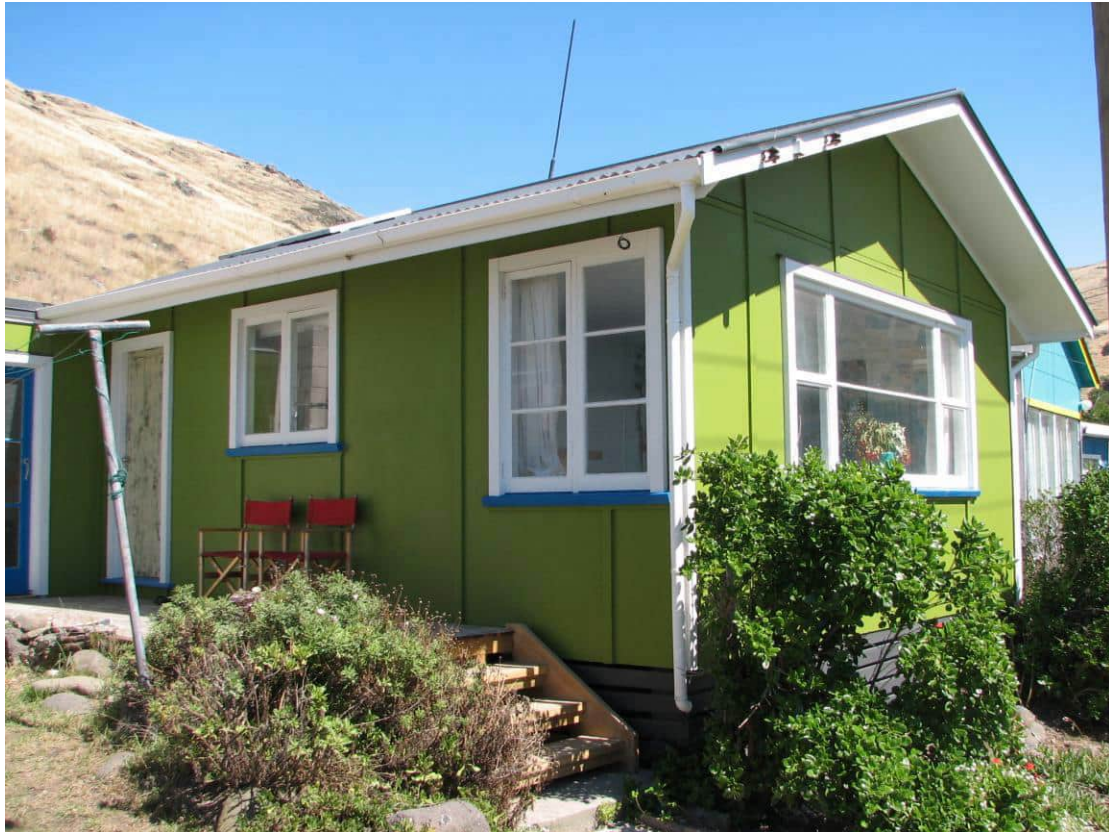
**PHOTOGRAPH: G. WRIGHT, 2017**

Bach 39 reflects the typology and characteristics of the 'kiwi' bach in its simple forms and materials. Built in c.1919, Bach 39 began (as did most the Rotten Row baches) as a diminutive lean-to weatherboard hut of one or two rooms, constructed of salvaged materials. Until the Scott family took over in the 1960s, the red-painted bach was virtually unaltered – and after 45 years, in poor condition. The Scotts altered and enlarged the bach significantly in 1965, adding a large gabled beach-facing living room at right angles to the original hut – a design strategy pursued by a number of Rotten Row bach owners. This more than doubled the bach's floor area. The whole building was clad in fibre-cement panel at this time. The roof is corrugated iron and the windows are timber framed. The bach sustained some damage in the Canterbury Earthquake sequence of 2010-2011, and has been subsequently re-clad like-for-like.

Bach 39 has technological significance as a vernacular building constructed and altered over time by its occupants to meet their requirements, and for its reflection of the building techniques and materials that were being used for baches in the mid-20<sup>th</sup> century. The changes over time followed the trend of building more substantial baches. The use of bought (rather than found) materials may have been a response to building regulations, as noted above, and the availability of materials such as fibrolite, which could be easily flat packed and carted, enabled construction at less cost than more traditional materials. Fibrolite fell out of favour in the 1970s and 80s<sup>15</sup> and is not found in later alterations to baches. The re-cladding of the bach following the Canterbury earthquakes has used a modern, safe version of this cladding material. The timber windows and corrugated iron roof are standard materials for baches of the period.

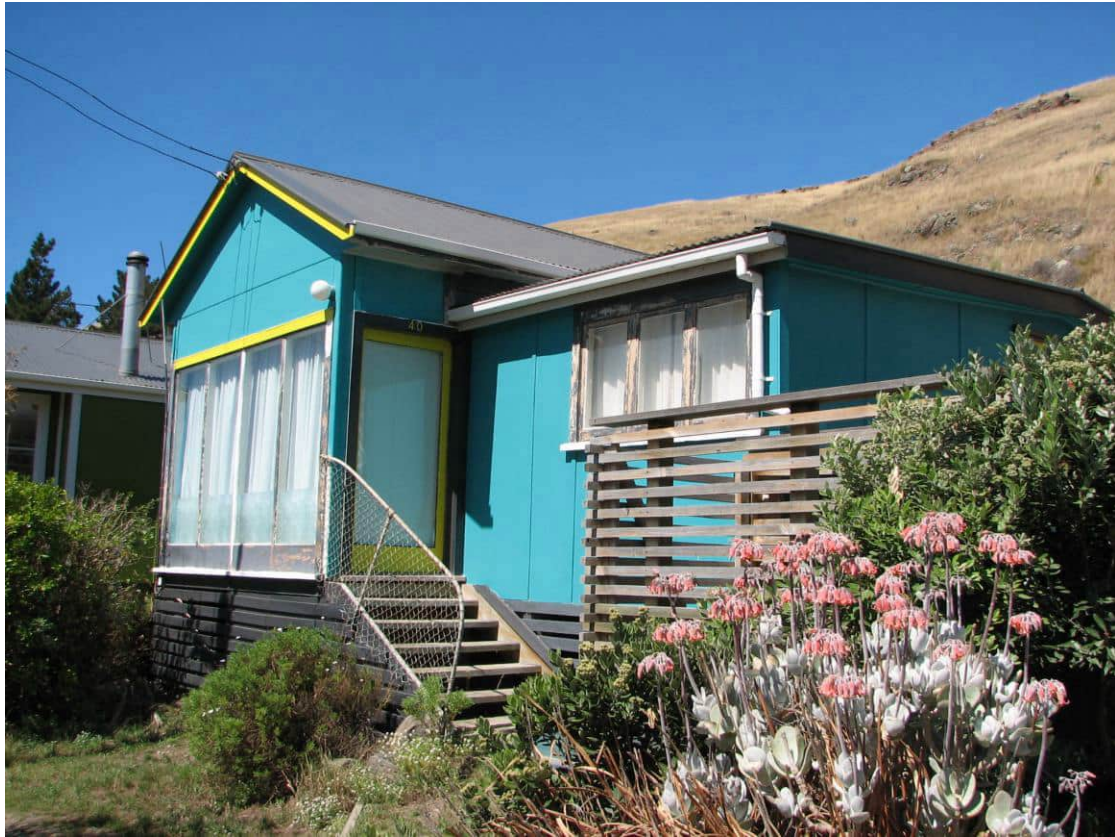
**PHOTOGRAPH: G. WRIGHT, 2017**

Bach 40 has technological and craftsmanship significance as a vernacular building constructed and altered over time by its occupants to meet their requirements, and for its reflection of the building techniques and materials of the early and mid-20<sup>th</sup> century. The changes over time followed the trend of building more substantial baches. The use of bought (rather than found) materials may have been a response to building regulations, as noted above, and the availability of materials such as fibrolite, which could be easily flat packed and carted, enabled construction at less cost than more traditional materials. Fibrolite fell out of favour in the 1970s and 80s<sup>18</sup> and is not found in later alterations to baches.

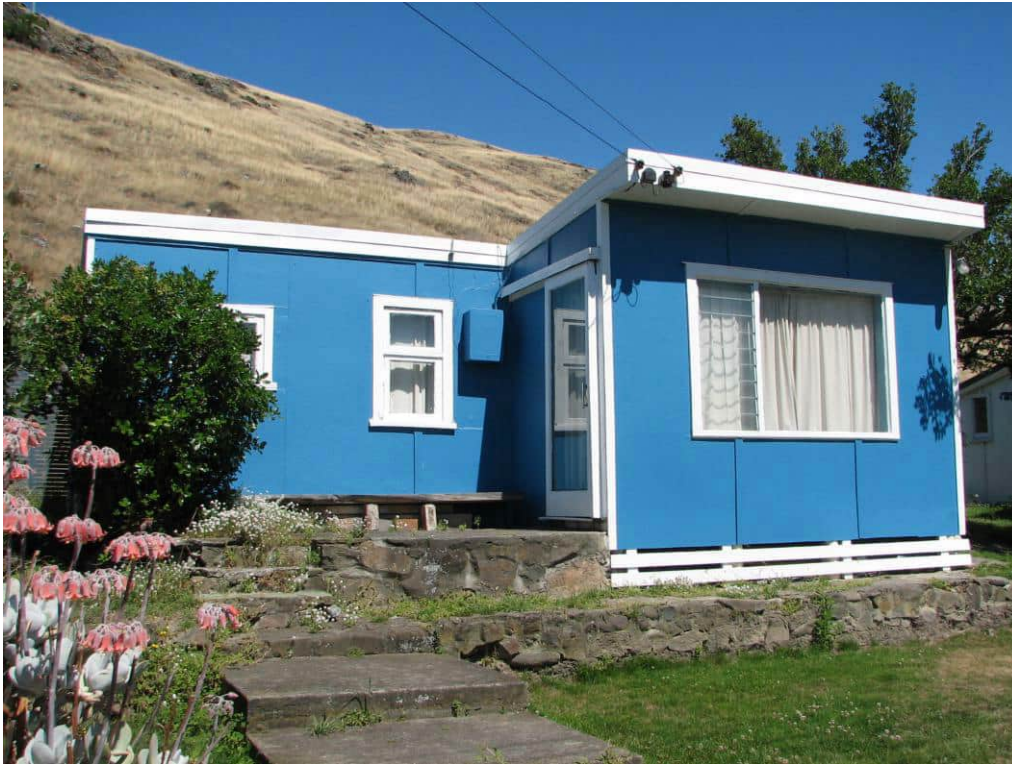
**PHOTOGRAPH: G. WRIGHT, 2017**

Bach 41 has technological significance as a vernacular building built and subsequently altered by its owners as needs dictated and means allowed, and reflecting the building techniques and materials of the early and mid-20<sup>th</sup> century. The changes over time followed the trend of building more permanent baches. The use of bought (rather than found) materials may have been a response to building regulations, as noted above, and the availability of materials such as fibrolite, which could be easily flat packed and carted, enabled construction at less cost than more traditional materials. Fibrolite fell out of favour in the 1970s and 80s<sup>20</sup> and is not found in later alterations to the baches, meaning this bach is very much a product of its time.

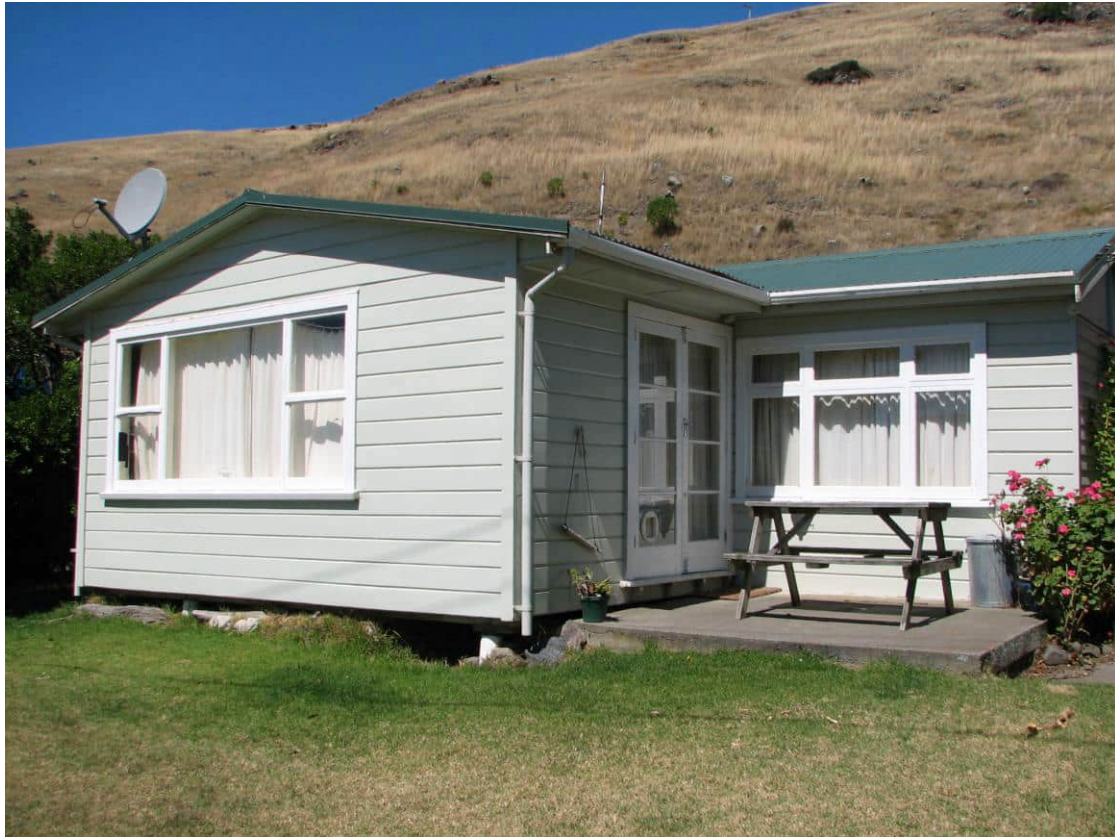
**PHOTOGRAPH: G. WRIGHT, 2017**

Bach 42 has technological significance as a vernacular building built and subsequently altered by the members of the Eastwick family as needs dictated and means allowed, and reflecting traditional building techniques and materials of the early and mid-20<sup>th</sup> century. The changes over time followed the trend of building more permanent baches. The use of weatherboards materials may have been a response to building regulations, and their retention rather than subsequent replacement in light weight Fibrolite (as was common for many baches) may be a reflection of their quality and condition, as well as the owner's material preferences.
